# approach

JULY 1978 THE NAVAL AVIATION SAFETY REVIEW

# ***A special safety program for special safety problems***

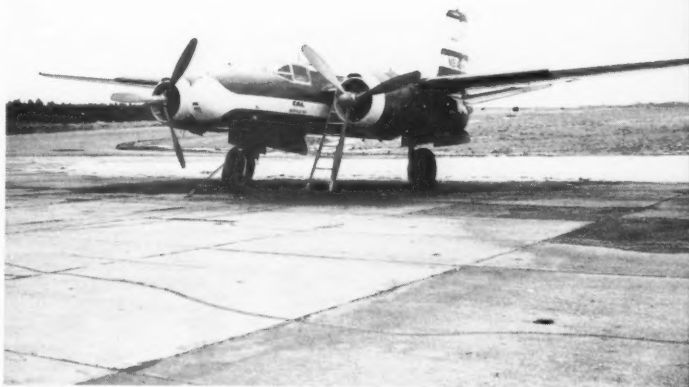
This B-26 is capable of programming different handling characteristics.

This safety record is particularly commendable considering the types of aircraft flown. In addition to common Fleet aircraft (although usually specially configured) such as the TA-4, T-2C, and A-7, the Test Pilot School operates some uncommon and unusual aircraft. Included in this category are the U-1B *Otter* and the U-6A *Beaver* — tailwheel airplanes with reciprocating engines and conventional flight controls. These are excellent vehicles in which to demonstrate lateral-directional flying qualities, and they provide classic examples of flight control and stability deficiencies. Another interesting aircraft is the X-26A *Frigate* — a glider. In addition to being one of the more enjoyable flying experiences at TPS, glider flight introduces the students to the handling characteristics associated with high aspect ratio wings divorced from the thrust and drag effects of a powerplant. A variable stability B-26 (owned by Calspan Corp.) is a one-of-a-kind aircraft

which can program different flight handling characteristics into its flying qualities.

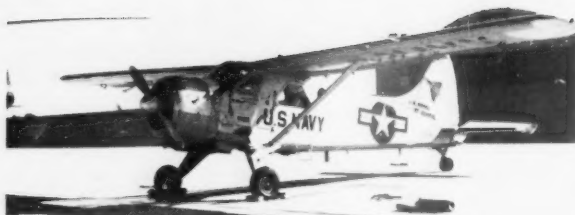
Tail draggers like this U-6 Beaver offer the TPS student experience in aircraft with very different handling characteristics.

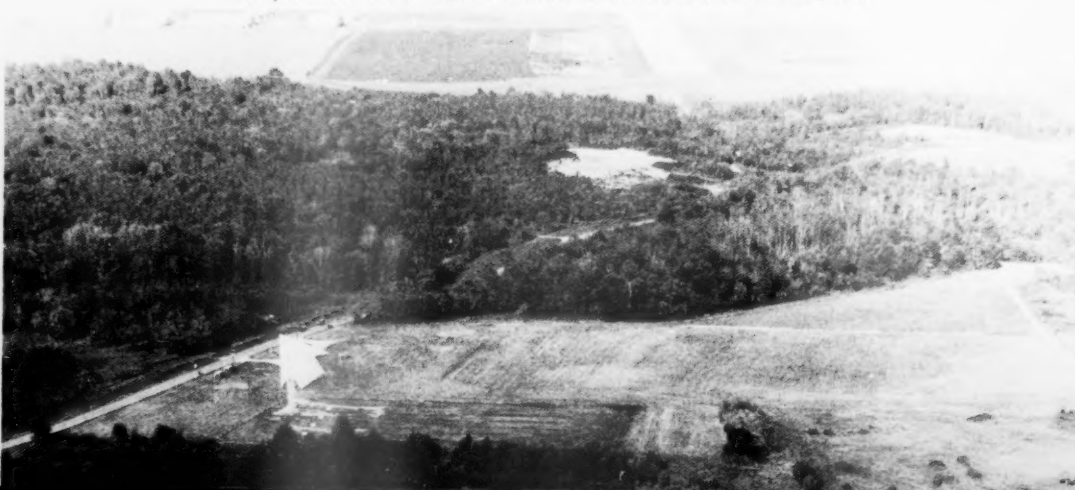
A rapid course reversal after takeoff resulted in the aircraft's stall and crash.

All evidence in the investigation pointed to a stall/spin/crash. Extensive investigation and analysis of wreckage failed to reveal any material failure that would have caused the accident. A computer printout revealed that the aircraft could not turn as tightly as it did, given its weight and speed, without stalling. And the AOA gage was recovered indicating a stalled angle-of-attack.

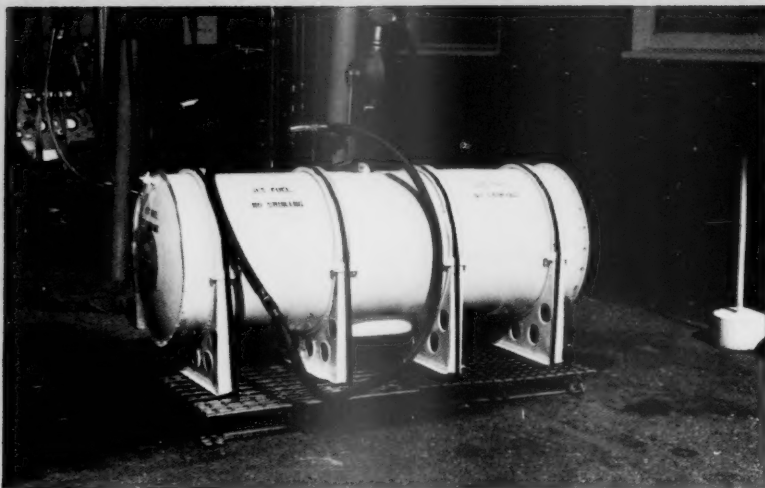
A 150-gallon, pickup-truck-transportable fuel tank. Weight at high-density altitudes equates with performance. A fuel supply in a parking lot at 9000-foot elevation and 70 miles from the nearest alternate source frequently means the difference between life and death or risk and safety.

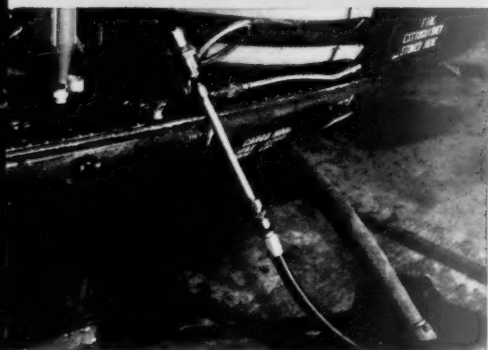
A fuel dump hose (RAMEC pending). The H-1 has no fuel dump system. A simple hose with the appropriate fitting allows quick depletion of an auxiliary fuel bag for a weight reduction of up to 1000 pounds (also ideal for LPH operations/cyclic times). This allows that 13,200-foot elevation landing when the planned 3½-hour search mission develops into a 1-hour rescue/retrieval mission.

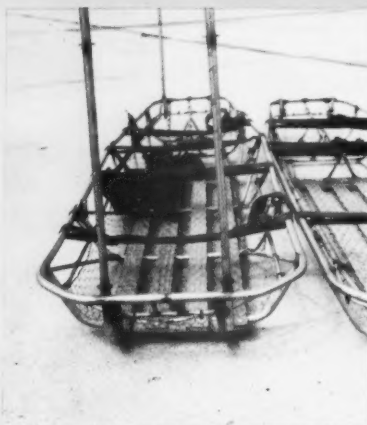
Compact stowage of two Stokes litters by the manufacture of four posts and eight cuffs (average fixed-wing crew of two). Stokes litters may also be cut in half to form a compact 3-foot bundle for storage and transportation and then be reunited through the use of unions for emergencies.

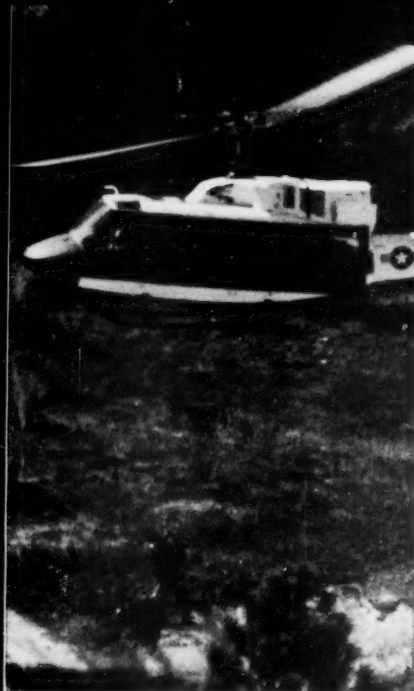
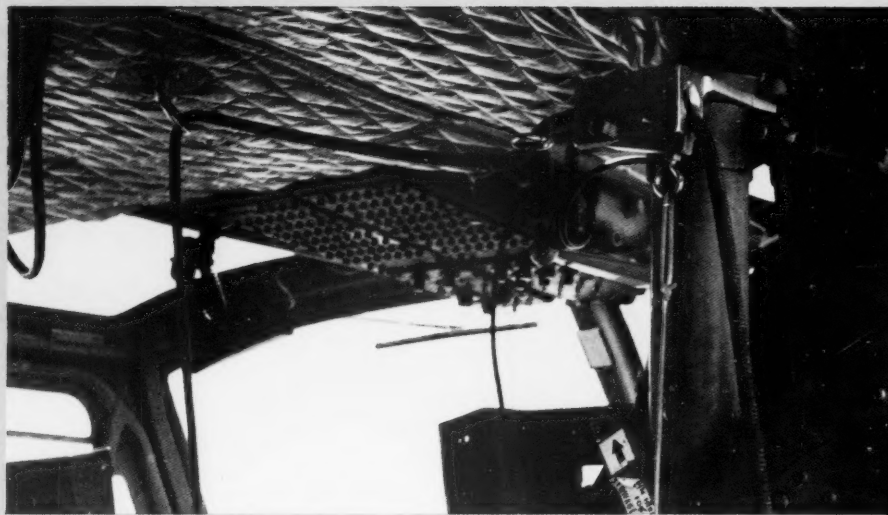
Design of a mechanical self-actuating brake for hoist training operations with a safety line (also applicable to H-2, H-46, H-3 type helos). (We are indebted to the NAS Lemoore SAR crew for their near-parallel endeavors and inspiration.)

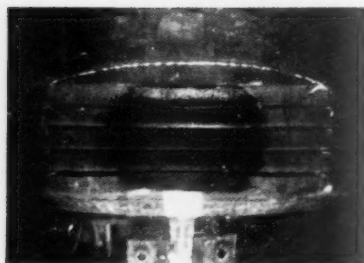
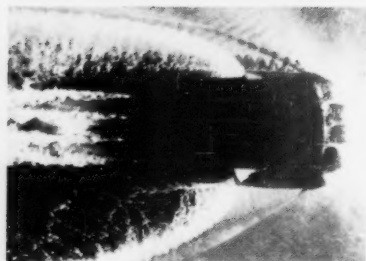
6° YAW ANGLE  
TIRE PRESSURE = 27 PSI

WATER DEPTH = 0.04 IN.

STATIC

22.8 MPH

40.7 MPH

41.4 MPH

62.6 MPH

87.8 MPH

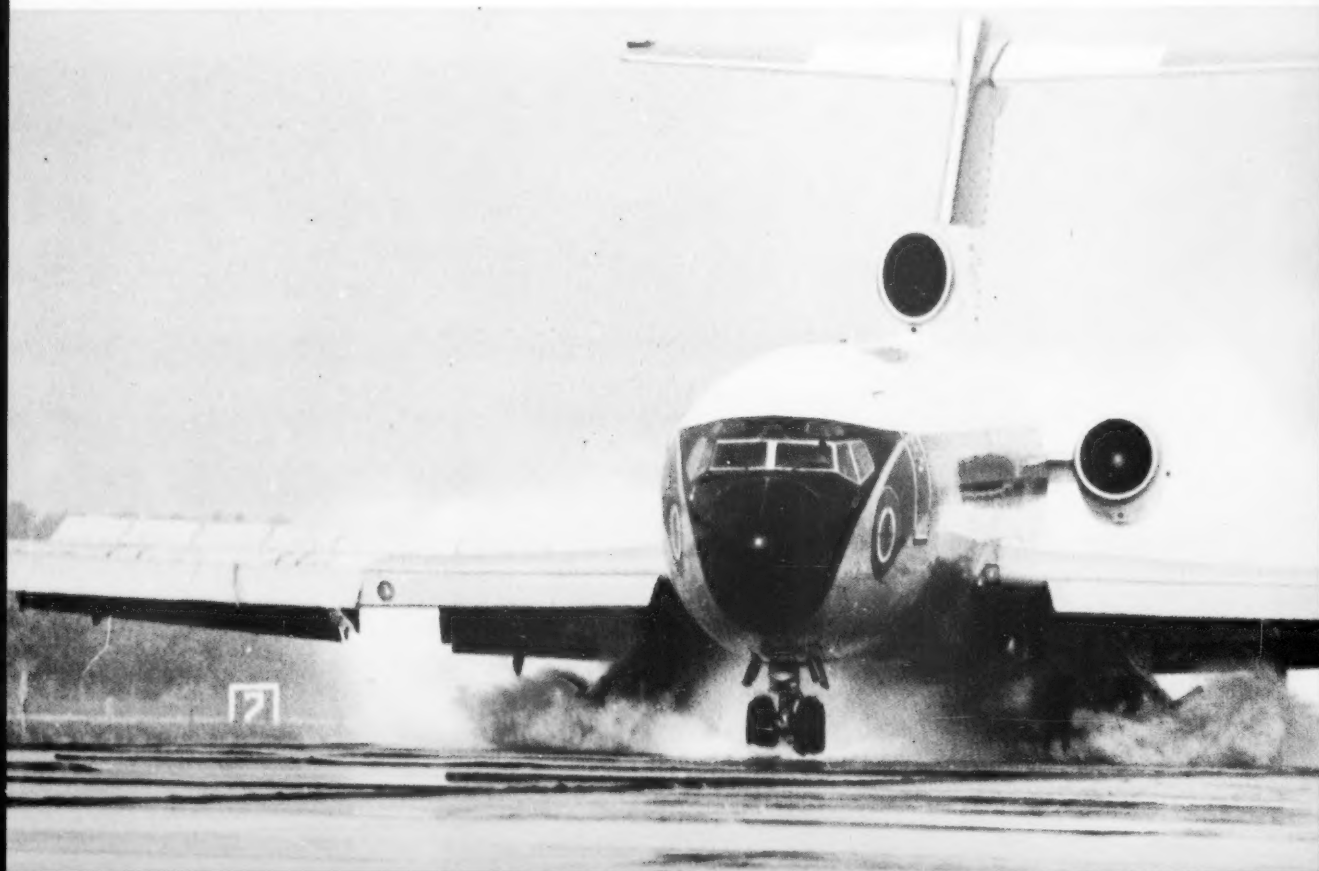
Hydroplane testing by NASA revealed much information about this dangerous phenomenon.

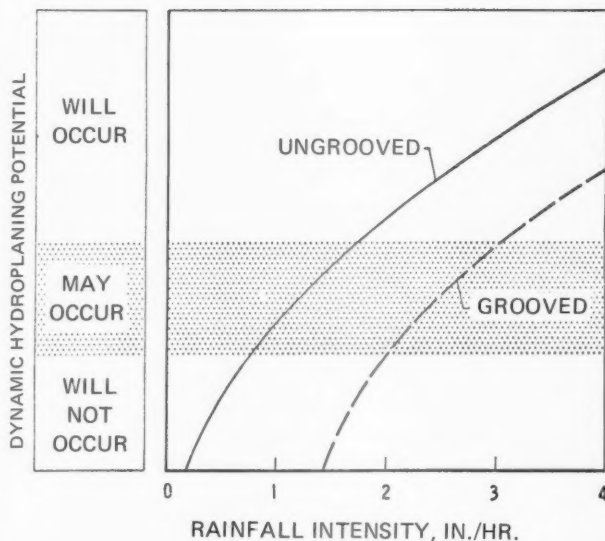
A comparison of grooved and ungrooved runway resistance to hydroplaning.

A textured runway surface is the single most effective means of combating viscous hydroplaning. Although transverse grooves in the runway pavement may increase tire wear, they will provide water escape channels and minimize the probability of the dynamic hydroplaning condition. Rubber deposits greatly reduce pavement texture in the touchdown zones and therefore represent an extreme hazard to the landing aircraft. Frequent removal of rubber using high-pressure water blasting or chemical solvents is mandatory to maintaining a safe runway surfacing.

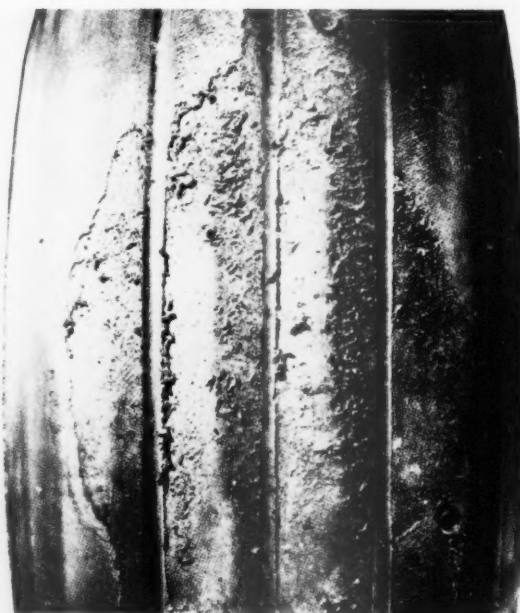
Reverted rubber from skidding on ice.

The third type of hydroplaning is called reverted rubber skid hydroplaning. The occurrence of reverted rubber skidding or hydroplaning is detectable by the presence of white streaks on the runway. Examination of the aircraft tire usually shows an elliptically-shaped tacky or molten rubber condition. It has been theorized that this condition develops from the generation of heat during a locked wheel skid. In effect, the tire rubber reverts to the molten or unvulcanized state; thus the derivation of the term "reverted rubber."
